1756 ControlLogix Controllers, Revision 17

ControlLogix Controller Catalog Numbers

1756-L61, 1756-L62, 1756-L63, 1756-L64, 1756-L65

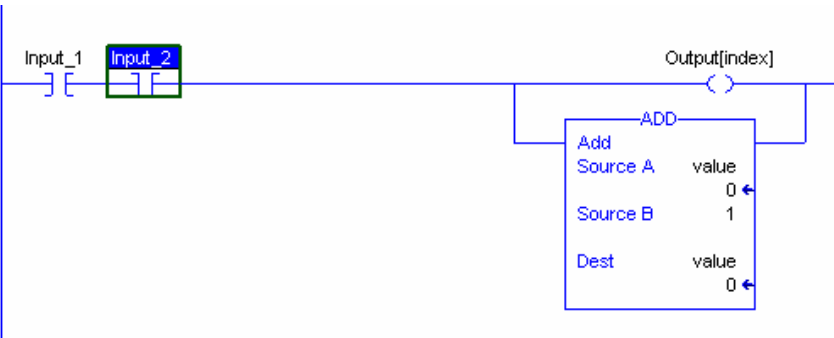
Cat. No.	Firmware Revision	Description
1756-L55Mxx, 1756-L61, 1756-L62, 1756-L63, and 1756-L64	17.04	Fault handlers can be defined at the controller and program scope levels. These fault handlers are typically used to handle major recoverable faults that can occur during runtime execution of an application due to programming errors. A typical example of this would be handling indirect addressing that has gone out of range; MyTag[index], where index is larger than the size of the array.
1756-L61S, 1756-L62S, 1756-L63S	17.08	<p>Faults can also be handled by the controller during pre-scan of the controller program on the transition to Run mode. Again, for example, the handling of indirect addressing that has gone out of range.</p> <p>There is an anomaly when these methods attempt to handle a fault.</p> <p>These are the possible ways the anomaly can manifest itself:</p> <ul style="list-style-type: none"> • The controller will experience a major non-recoverable fault. I/O goes to their configured safe state, and the user application is cleared from memory. At this point, a Code 1 Type 60 or 61 major recoverable fault will be logged in the controller. This requires you to redownload the application. • Tag data corruption. • Online saving or uploading failures. • Anomalous program execution. <p>For example, if a rung is being scanned false and there is an instruction that has false execution, the fault handler executes so the remainder of the rung will scan true. In the example below, the OTE instruction has an index out of range. After returning from the fault handler, the ADD instruction will execute, even though the rung input conditions are false.</p>
